Schofield Barracks, Wheeler Army Airfield & Fort Shafter Oahu, Hawaii

Crash Location Enhancement Studies

March 2000

Gannett Fleming, Inc.

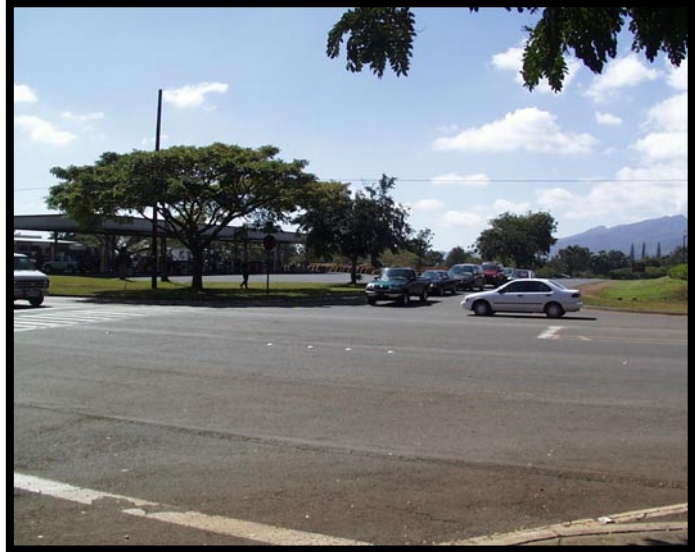
Figure 4. Intersection of Foote Avenue and A Road (southward view)

- **Control:** STOP control on A Road approaches
- **Speed Limit:** 25 mph on all approaches
- **Roadside Hazards:** None
- **Sight-distance Restrictions:** Southbound traffic, looking eastward (towards Foote Avenue Gate), has limited sight distance
- **Street Lighting:** Northeast and southwest quadrants
- **Morning Peak Hour Traffic:** Total intersection volume of 873 vehicles (refer to fig 6 for turning movement counts)
- **Mid-day Peak Hour Traffic:** Total intersection volume of 1,244 vehicles (refer to fig 6 for turning movement counts)
- **Evening Peak Hour Traffic:** Total intersection volume of 1,188 vehicles (refer to fig 6 for turning movement counts)
- **Pedestrian Level:** Minimal at time of data collection with exception of PT activities during morning time period
- **Restrictions:** None

The 3-year crash history includes 32 crashes. Eight crashes were category 1 crashes, 21 were category 3 crashes, and 3 were category 4 crashes (involving injuries). During data collection activities, several “near misses” were observed. The majority of “near misses” would have been right-angle collisions with some being rear-end collisions. Several times, vehicles making the southbound left-turn movement from A Road turned behind vehicles waiting to make a westbound left-turn movement from Foote Avenue (cut-behind movement).

- Relocate the destination sign posted on the northeast quadrant of the intersection. The sign should be moved eastward to provide additional sight distance to southbound traffic. The estimated cost of this improvement is \$250.
- Although not warranted at this time, an exclusive eastbound right-turn lane may be required to accommodate the additional traffic resulting from the Kolekole Connector Road Project. If constructed, the turning radii should be increased to accommodate truck traffic. During data collection several vehicles were observed “jumping” the curb.

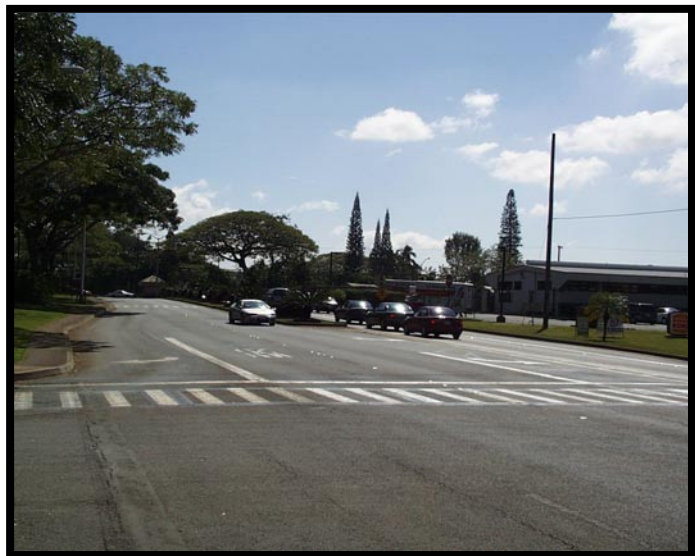
Figure 5. Intersection of Foote Avenue and A Road (eastward view)

- During the mid-day peak hour, queues of 10+ vehicles were observed on the northbound approach.
- Westbound left-turn lane traffic experienced queuing beyond capacity several times throughout the day. It should be noted that the westbound left-turn lane is to be extended as part of the Kolekole Connector Road Project that is currently under construction.
- Outbound (eastbound) traffic queues were observed extending from Kunia Road through the study intersection several times during the peak-hour periods.

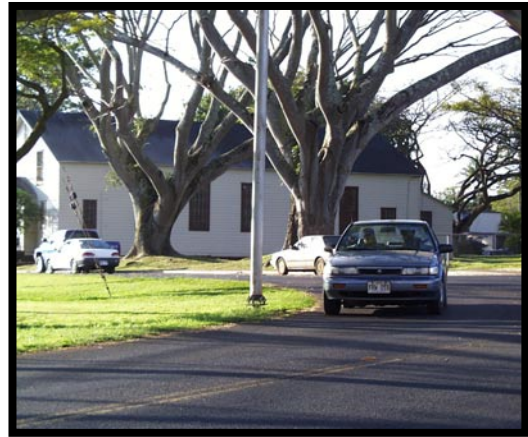
Figure 8. Light pole on Cadet Sheridan Road near Williston Avenue (southward view)

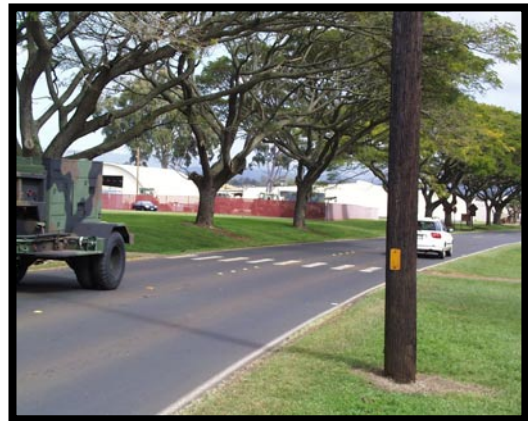
Figure 9. Utility pole within clear zone along Lyman Road near golf course (eastward view)

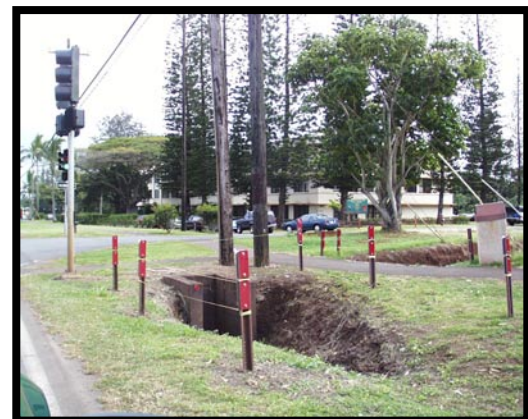
Figure 10. Post mounted signal pole at intersection of Lyman Road and Humphreys Road (eastward view)

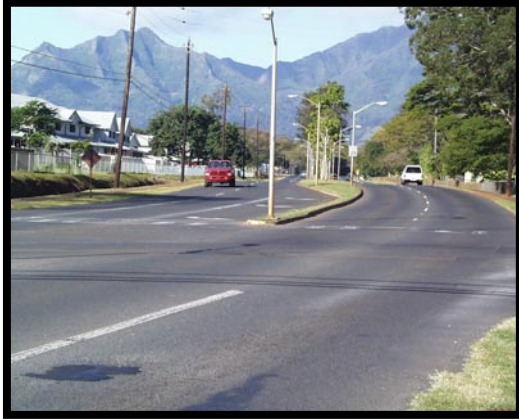
Figure 11 shows a light pole that is centered within a 2-foot wide median on Trimble Road at its intersection with Hewitt Street. This condition was also noted at the intersection of Lyman Road with Carpenter Street. These light poles are an unnecessary obstruction that should be removed. Light poles should be placed at intersection corners, rather than within the median where they present a hazard to opposing traffic flows.

Figure 11. Light pole in median at the intersection of Trimble Road and Hewitt Street (westward view)

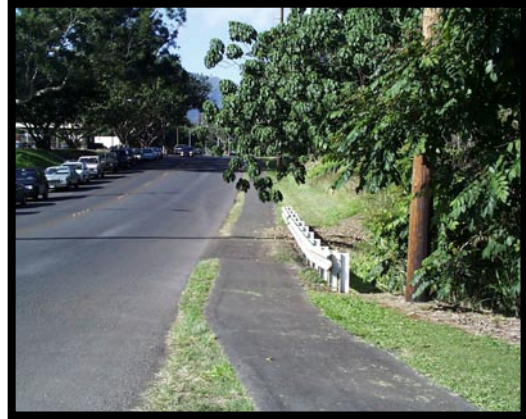
Guardrail used to protect steep slopes or other obstructions can sometimes become an obstruction in itself. In figure 12, a section of guardrail is shown on McCornack Road near Waianae Avenue. The guardrail is protecting a steep sideslope; however, its blunt end introduces a hazardous obstruction. An end treatment, in accordance with NCHRP 350, is required here. In

addition, this guardrail lies close enough to a power pole that extending it slightly would

Figure 12. Blunt-end guardrail located along McCornack Road near Waianae Avenue (westward view)

also protect the pole. When damaged, guardrail can become more of a hazard than what it is protecting (fig 13). For this reason, damaged sections should be replaced as soon as possible.

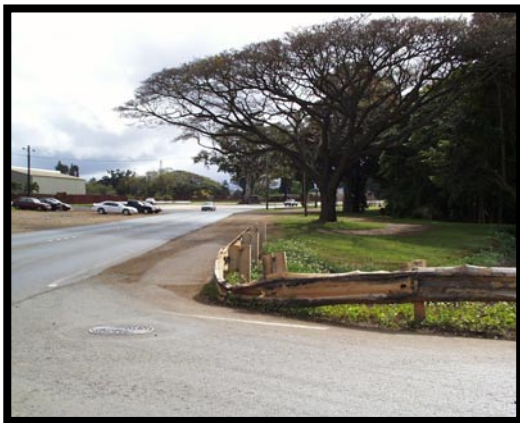
Figure 13. Damaged guardrail at the intersection of Lyman Road and Duck Road (eastward view)

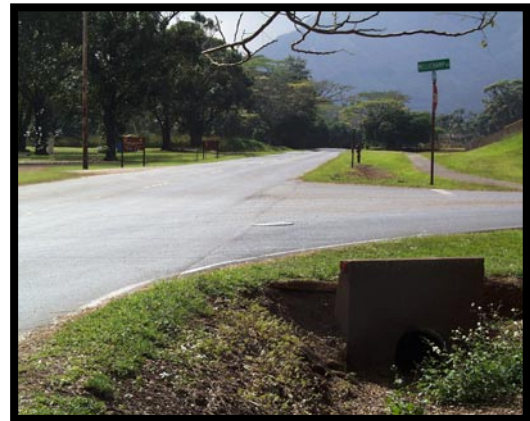
Figure 14. Drainage inlet within clear zone at intersection of Lyman Road and Mellichamp Road (westward view)

Many drainage features on post are serious safety hazards because they present obstacles that may be impacted by motorists. Figure 14 shows a protruding headwall at the intersection of Lyman and Mellichamp Roads that should be replaced. Figure 15

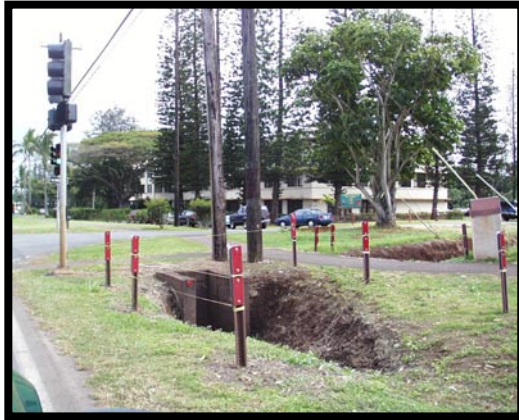
shows the intersection of Lyman and Humphreys Roads where an unprotected headwall, located within the clear zone, protrudes in such a way that the roadside is non-traversable. This headwall should be replaced with a sufficiently sized inlet.

Figure 15. Drainage inlet delineated with posts and wire at intersection of Lyman Road and Humphreys Road (eastward view)

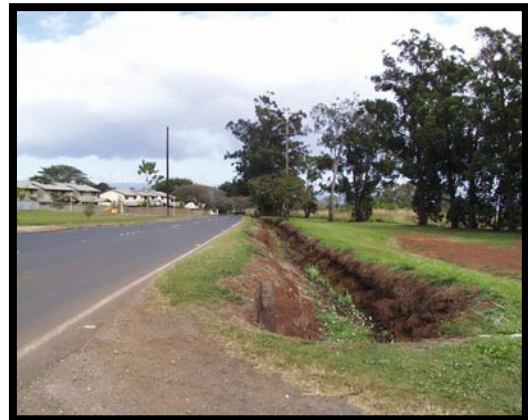
Figure 16. Drainage swale within clear zone along Lyman Road east of Mellichamp Road (eastward view)

Figures 16 (Lyman Road) and 17 (McMahon Road) show where drainage swales present a hazard by introducing a steep sideslope close to the edge of travelway. Where possible, closed drainage systems should be installed. If this is not practical, guardrail should be installed. Figure 18 illustrates where guardrail has been used to shield a steep sideslope to a drainage swale on Lyman Road. Due to erosion and the deterioration of guardrail posts, it is not likely that the guardrail would withstand a vehicle impact. This section of guardrail should be replaced.

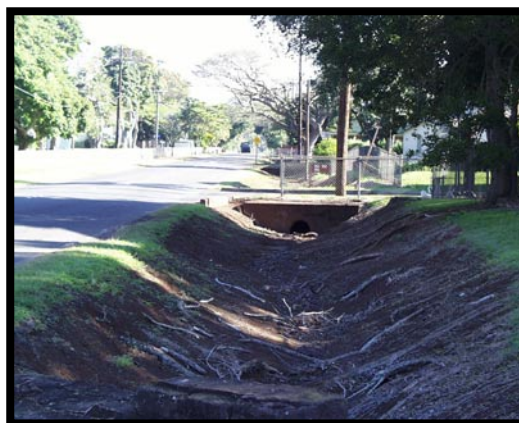
Figure 17. Drainage swale and inlet within clear zone along McMahon Road near Carpenter Street (northeastward view)

On McMahon Road, a closed drainage system has been installed. However, the headwalls are not traversable and rigid steel posts, used to protect the concrete swale, introduce a fixed object hazard. The installation of several inlets would be preferable to

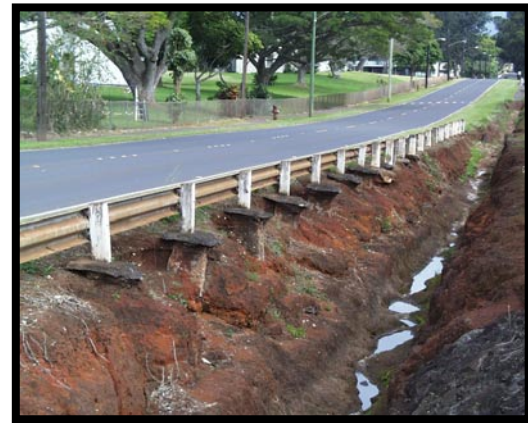
Figure 18. Unstable guardrail along Lyman Road east of Mellichamp Road (eastward view)

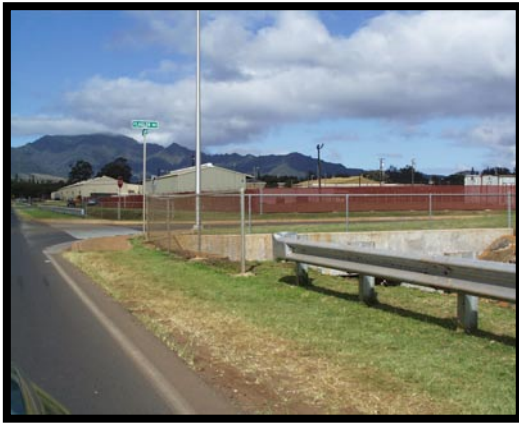
the large protruding drainage structures. Figure 19 shows a large drainage structure along Lyman Road, near Flaggler Road, where a chain link fence is used to separate it from traffic. The nearby guardrail should be extended to properly protect traffic from this structure.

Figure 19. Drainage structure along Lyman Road near Flaggler Road (westward)

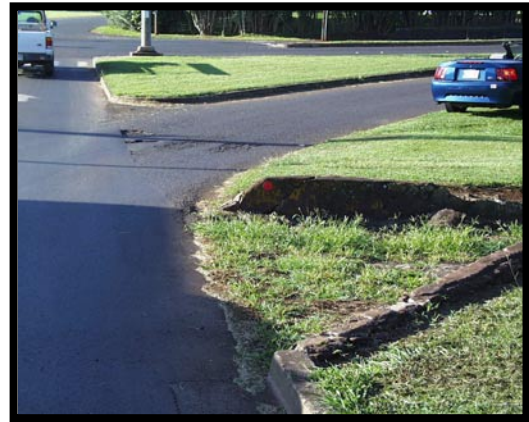
Figure 20. Curb inlet at the intersection of Cadet Sheridan Road and Trimble Road (southward view)

Curb inlets, such as the one at the intersection of Cadet Sheridan and Trimble Roads (fig 20) should be redesigned. Curbing should be continuous around this turn with the inlet opening transition designed to reduce the potential of a motorist jumping the curb.

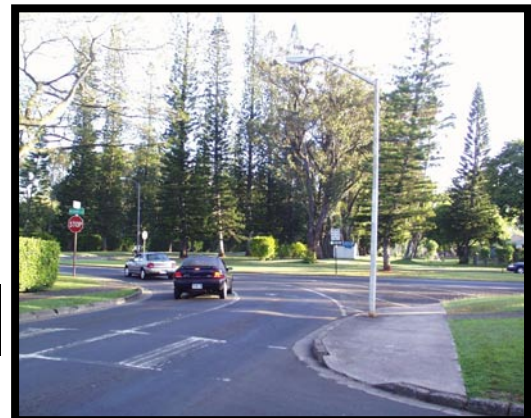
Most pavement markings throughout the post are worn and faded. Figure 21 shows a westward view of a crosswalk at the intersection of Trimble Road and Cadet Sheridan Road that is barely visible.

Figure 21. Faded crosswalk at intersection of Waianae Avenue and Kolekole Avenue

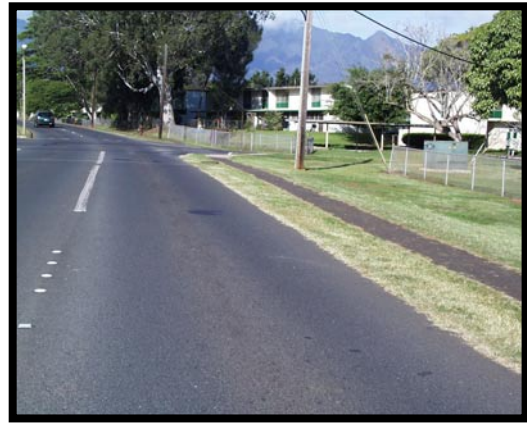
On Trimble Road, a sidewalk paralleling the roadway is offset only three feet from the edge of travel way (fig 22). If a motorist were to even slightly drift off the road and hit a pedestrian, the results would likely be catastrophic. Where sidewalks are present along the roadway, curbing should be installed to reduce the chance of an errant vehicle encroaching on the sidewalk.

Figure 22. No curbing to protect sidewalk along Trimble Road near Hewitt Street (westward view)

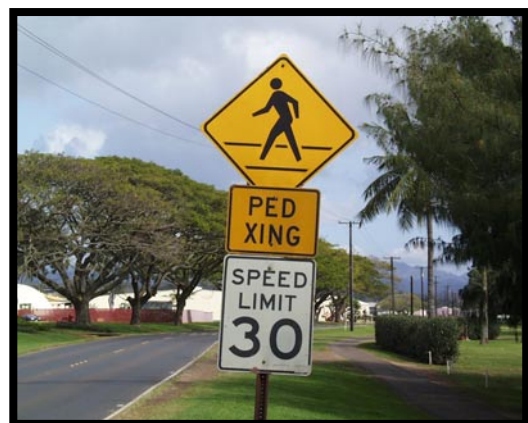
- Unrelated signing should not be installed on a single post. An example of that was found on Lyman Road (fig 23) where a regulatory and warning sign are both mounted on a single post.

Figure 23. Warning and regulatory signs mounted on a single post along Lyman Road (eastward view)

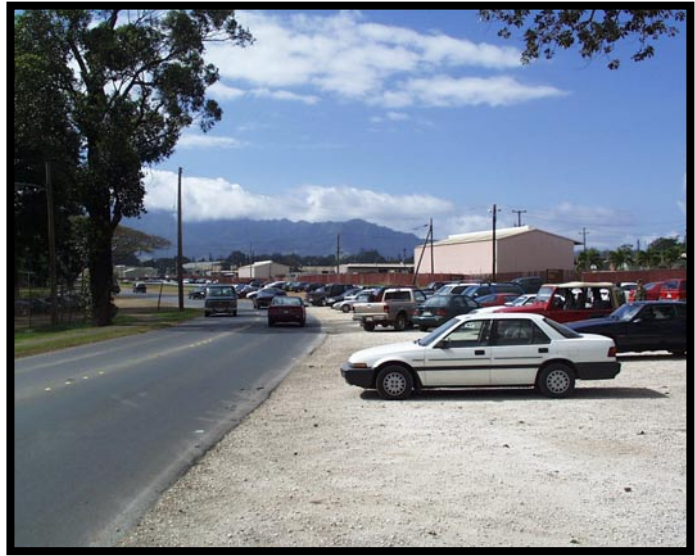
The portion of Lyman Road near Lyman Gate allows head-in parking immediately adjacent to the travel way (fig 24) and has no controlled access. This creates a conflict between vehicles maneuvering into and out of the parking spaces and through-traffic on Lyman Road. Head-in parking should be eliminated in this area. An alternative to removing the on-street parking is to install curbing. Curbing will control access to the lot and reduce the conflict with Lyman Road traffic.

**Figure 24. Parking along Lyman Road
near Lyman Gate (westward view)**

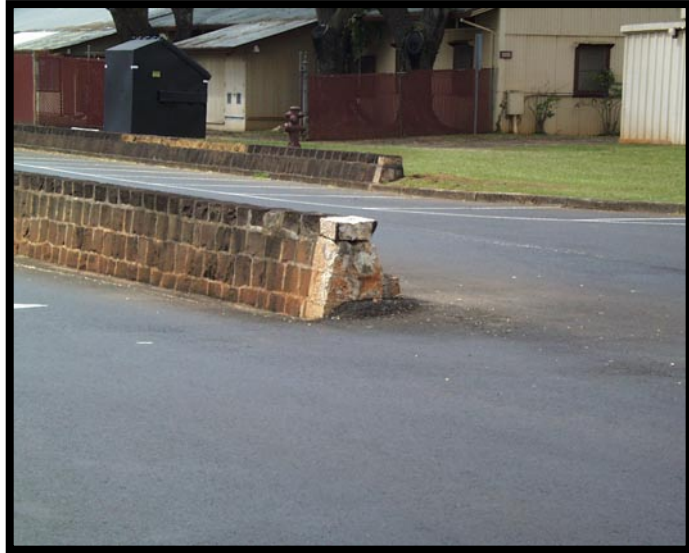
Generally, fixed objects lie outside the required clear zones. One exception is at the west end of Wright Avenue near the gatehouse. A concrete wall that divides opposing traffic flows (fig 25) presents a safety concern. It appears that the end of this wall has been damaged in the past. The gate relocation project that will align Wright Avenue with Lyman Gate on Schofield Barracks should address this concern.

Figure 25. Blunt end rock wall on Wright Avenue near Foote Avenue (westward view)

If the gate relocation is delayed, the concrete wall could be temporarily protected with an approved crash attenuator. Because installation of an attenuator may not be aesthetically pleasing, another alternative is to taper the end section down to eliminate the blunt end. Since speeds are low on Wright Avenue the risk of vehicles ramping up the tapered end would be minimal. If the end is tapered, it should be marked with a Type II or Type III object marker in accordance with section 3C-3 of the MUTCD.

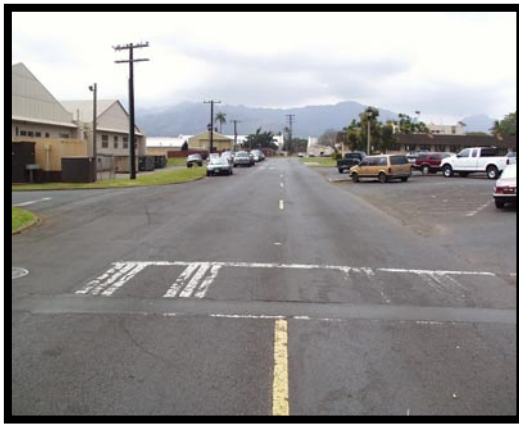
Most pavement markings throughout the post are worn and faded (fig 26). A regular maintenance schedule should be followed to ensure that worn markings are replaced. The area of Kahana Road, near Lehua Road, consists of new pavement markings which are in conformance with the MUTCD (fig 27). Kahana Road should be the example for other roadways on post in need of new pavement markings. Most roadway centerlines are marked with a single broken yellow line. To prohibit passing, these

Figure 26. Faded crosswalk markings on Santos Dumont Avenue (westward view)

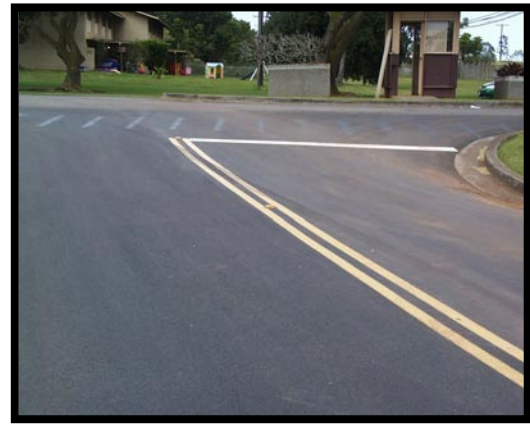
Figure 27. Pavement markings at the intersection of Lehua Road and Kahana Road (northward view)

centerlines should be replaced with double solid yellow lines consistent with Kahana Road.

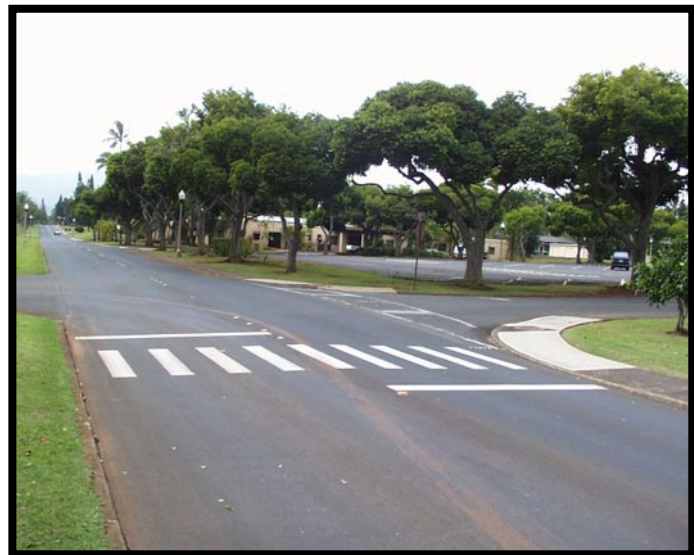
Crosswalks and the appropriate signing should be in accordance with the MUTCD as previously shown in figure 7. Stop bars in advance of the crosswalk on Wright Avenue (fig 28) are not required. School Advance signs (S1-1) should be installed in advance of crosswalks in front of the elementary school located on Old Kamehameha Highway and Leilehua Road. Groups of crosswalks on Santos Dumont and Wright Avenues should be signed with a single Advance Crossing sign (W11-2) in each direction.

Figure 28. Incorrect use of stop bar for crosswalk at the intersection of Wright Avenue and Warhawk Street (westward view)

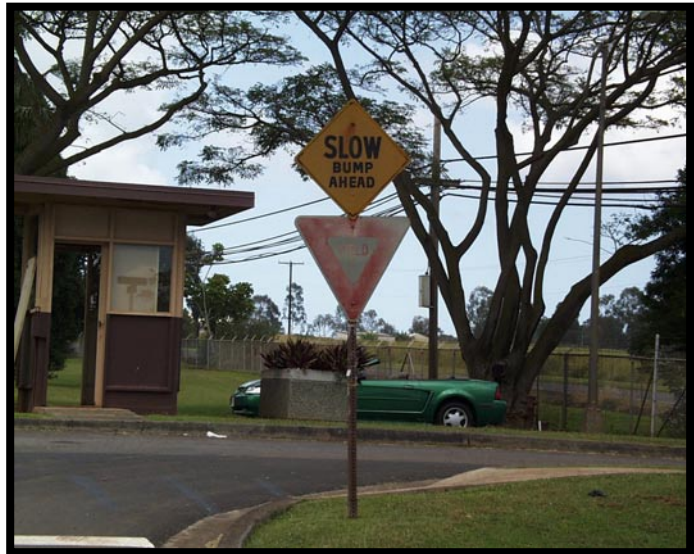
- The Kahana Road approach to Lehua Road is posted with an extremely faded YIELD sign and a sign warning “SLOW BUMP AHEAD” when no such bump exists (fig 29).
- Wright Avenue is divided by a wide grass median and is intersected by numerous one-way side streets. At these intersections ONE WAY (R6-1) and STOP control (R1-1) signing is not always present to clarify the direction of travel for motorists approaching from Wright Avenue. Figure 30 illustrates signing procedures for divided roadways.

Figure 29. Faded warning and regulatory signs on single post at the intersection of Lehua Road and Kahana Road (northward view)

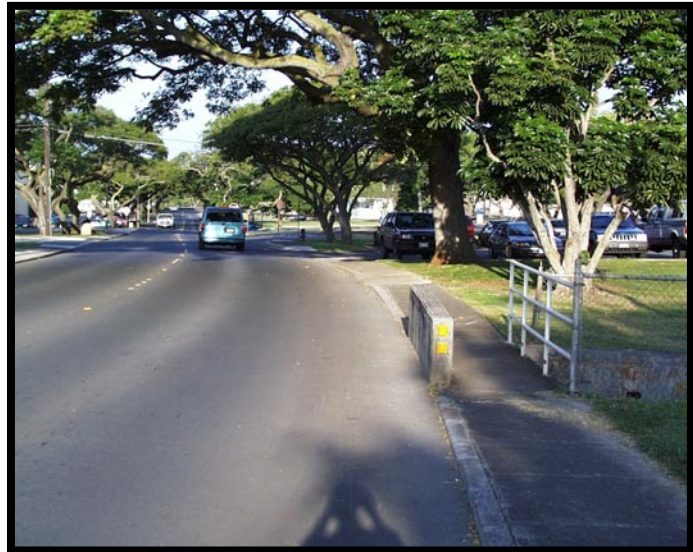
Most post roadways provide an adequate clear zone, free of fixed obstructions. The majority of the primary corridors consist of curbed roadway sections that help prevent errant vehicles from exiting the roadways. Figure 31 shows an unprotected bridge parapet on Wisser Road. A similar situation was found on Funston Road near its intersection with 'I' Place.

Figure 31. Wisser Road – Blunt end parapet (northward view)

shown at left, mark the object and direct traffic in the appropriate direction to reduce the potential for impact. The downward direction of the stripes indicates the direction of travel.

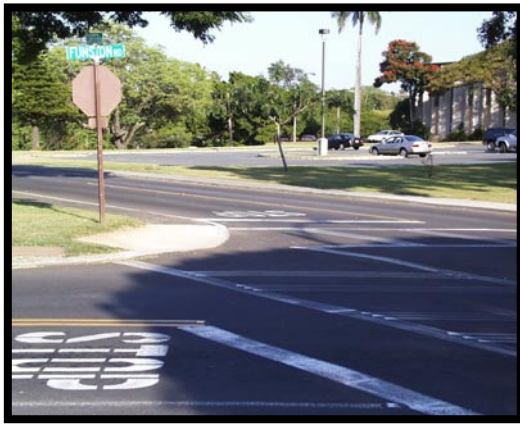
Figure 32. Intersection of Funston Road and Carter Drive (northward view)

Most pavement markings throughout post are in good condition; however, in some instances, their application is inconsistent. At the intersection of Funston and Wisser Roads (fig 32), the Wisser Road approach is marked with a single solid yellow centerline. The Funston Road approach consists of a double solid yellow centerline marking. As previously discussed under the safety audit definitions, double yellow markings should be used. At this same intersection, two different crosswalk markings

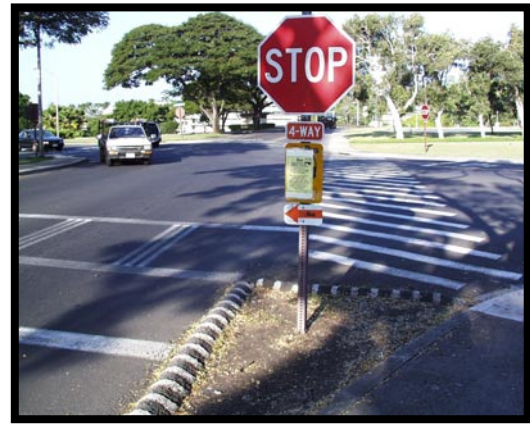
Figure 33. Intersection of Funston Road and Carter Drive (northward view)

are used (fig 33). Each is acceptable but a consistent type of marking should be established throughout the installation.

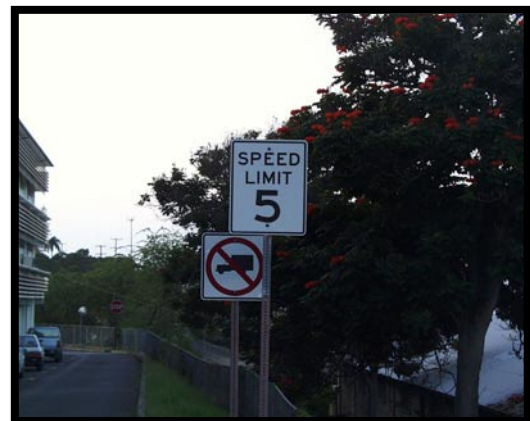
Figure 35. Speed limit sign on F Street (southward view)

- Minimum speed limits are typically posted at 25 mph. Unrealistically low speeds (fig 35) are the greatest abuse of traffic control and should be corrected. Numerous speed studies have shown that drivers tend to operate at speeds that are reasonable to them. If speed limits are lower than necessary, many drivers will ignore them, thus creating conditions worse than those that would result from higher speed limits. Speed limits should be set after an engineering and traffic investigation has been made in accordance with established traffic engineering.
- Sign posts should normally consist of a single sign unless a second sign is supplements the meaning of the primary sign. On Wisser Road a bus stop sign is mounted on the same post as a STOP sign (fig 33). This bus stop sign could take away from the intended meaning of the STOP sign.

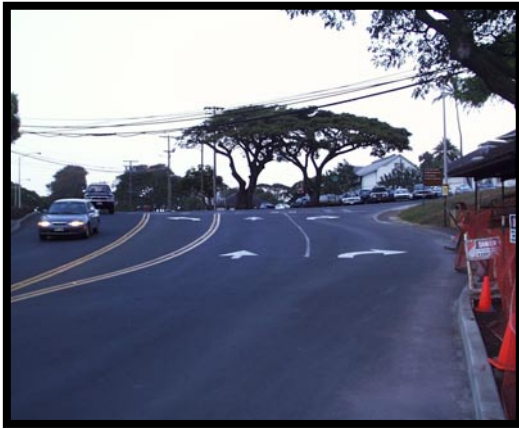
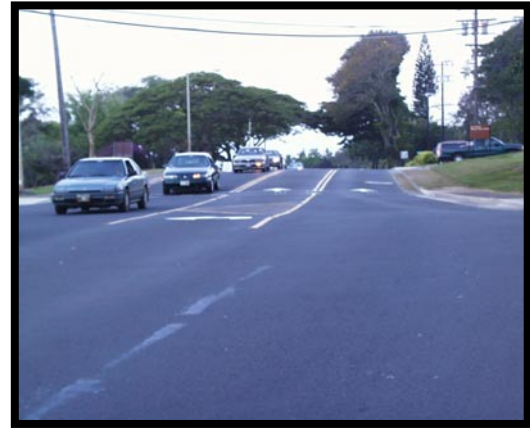
- The left-turn lane in the westbound direction uses incorrect lane line colors (figs 40 and 41). Yellow lines are used to separate traffic travelling in opposite directions. White lines are used to separate traffic travelling in the same direction. As can be seen in figure 40, a double yellow lane line separates the left-turn and through lanes on the westbound approach to the intersection. This line should be a solid white line. The transition area can be marked with white skip guide lines or have no markings. Figure 41 illustrates a solid single yellow lane line used improperly to separate traffic flow in the same direction. This line should be a solid white line.

Figure 40. Approaching intersection of Funston Road, C Street and G Street (westward view)

Figure 41. At intersection of Funston Road, C Street and G Street (westward view)

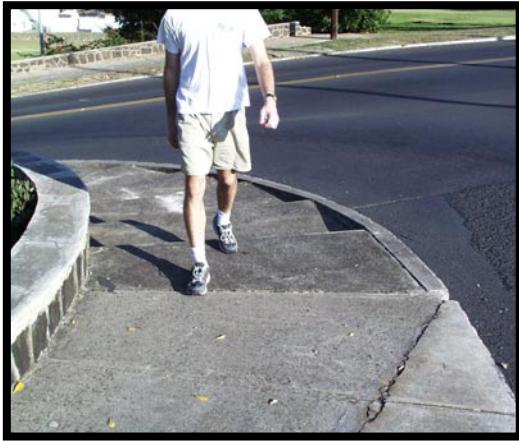
Figure 42. Intersection of Funston Road and Bonney Loop (northward view)

The sidewalk located in the southwest quadrant of the intersection includes steps (fig 42). This treatment is not compliant with ADA requirements and should be replaced by a ramp.
